# Manhole Inspection Summary

Manhole # S47G2\_017MH

Insp Date: 1/14/08 1:37 PM

**Location** Address: **1603 Filbert St**

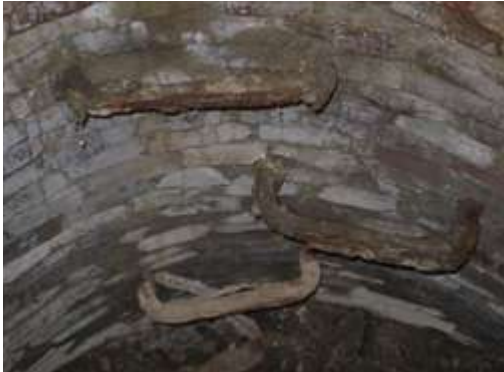
Steps

**Steps** Count: **3** Missing: **0** ☒ **Corroded**

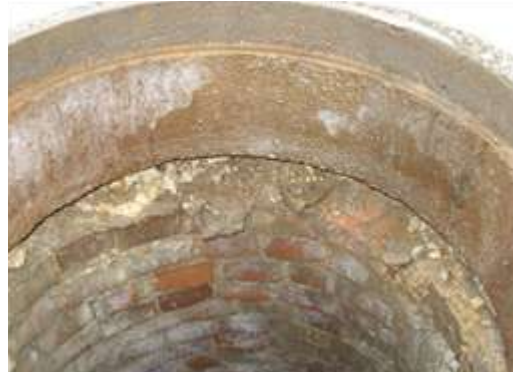
Defect 1

Condition: ☐ Sound ☐ Cracked ☐ Root Intrusion ☒ **Loose Brick** ☐ Deteriorated

Infiltration: ☐ None ☐ Joint ☒ **Cracks** ☐ Mortar ☐ Roots ☐ Wall

Chimney

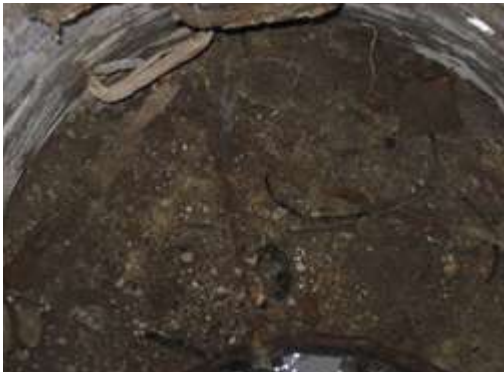
Defect 2

Condition: ☐ Sound ☐ Cracked ☐ Root Intrusion ☐ Deteriorated ☐ Leaks ☒ **Debris**

Debris

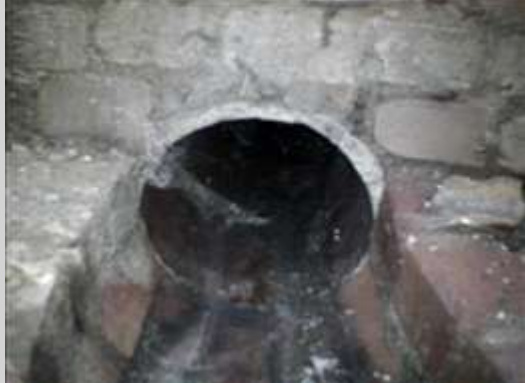
12 O'Clock Outflow

8 in. Circular Gravity Sewer  
Pipe Out @ 12 O'Clock

Pipe Height: **10.8** (in.) Rod and Bar (Angled)  
Pipe Material: **Clay** ☐ Pipe Lined  
Invert Depth: **7.81** (ft.) Flow Characteristics: **Fast**  
Deposits: ☒ None ☐ Mud ☐ Sludge ☐ Debris ☐ Grease  
Silt Depth: (in.) Deposits Extent:  
Infiltration: **None** Pipe Seal Cond: **Sound**

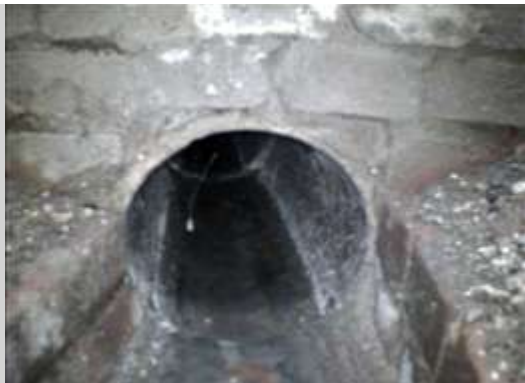
3 O'Clock Inflow

8 in. Circular Gravity Sewer  
Pipe In @ 3 O'Clock

Pipe Height: **10.8** (in.) Rod and Bar (Angled)  
Pipe Material: **Clay** ☐ Pipe Lined  
Invert Depth: **7.67** (ft.) Flow Characteristics: **Fast**  
Deposits: ☒ None ☐ Mud ☐ Sludge ☐ Debris ☐ Grease  
Silt Depth: (in.) Deposits Extent:  
Infiltration: **None** Pipe Seal Cond: **Sound**
